GEOECOLOGICAL ASSESSMENT OF DANGEROUS NATURAL PROCESSES DEVELOPMENT FOR THE BLACK AND AZOV SEAS COASTS WITHIN THE TAMAN REGION

The work is devoted to geoecological assessment of dangerous natural processes development for the Black and Azov seas coasts within the Taman peninsula. Special consideration has given to a factor of tectonic instability for the region. By the example of the events has shown that this factor must stay at first place during geoecological risk assessment.

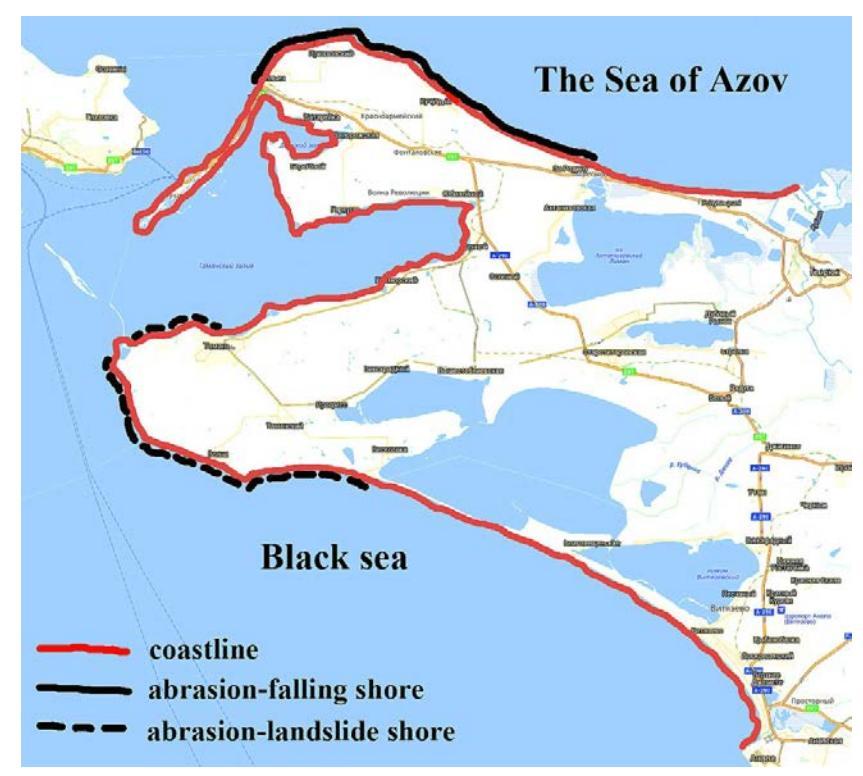
Fig. 1. Taman peninsula.

The Taman peninsula coastline length is 230 km approximately. Abrasion, abrasionlandslide and abrasion-falling destruction of coastal structures cover 60 km (26%) of the seacoasts (Fig. 1). 30 km (13%) of this shore type is placed along of the Azov sea (from the Peresyp to the village of Ilyich). 30 km (13%) – along of the Black sea (from the Taman to Veselovka).

The average speed of the shore breakdown for the listed type of destruction is 1.0-1.5 m/year, maximum – 4.0-6.0 m/year. Abrasion-falling type of shore is characteristic for loamy and clay structures. These structures have elevated the abrasion rate (1.8-2.5 m/year). This type of shore was fixed along the coastal line of the Azov sea (Fig 1). Abrasion-landslide shore exists where presence the sandy sediments. This type of shore is usual for the marked on Fig. 1 the Black sea coastline. This structure has abrasion rate about 0.5-0.6 m/year.

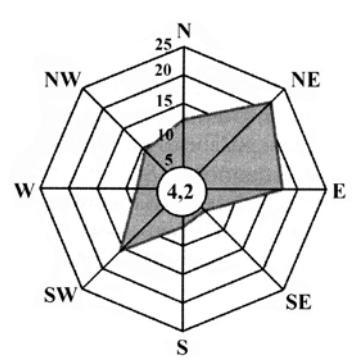
Fig. 2. The frequency of occurrence (%) of wind directions and calms (in the circle) over the Taman peninsula.

Additionally, the increased retreat rate of the shore of Azov sea connected with high repeatability of winds of northeast direction (Fig. 2).

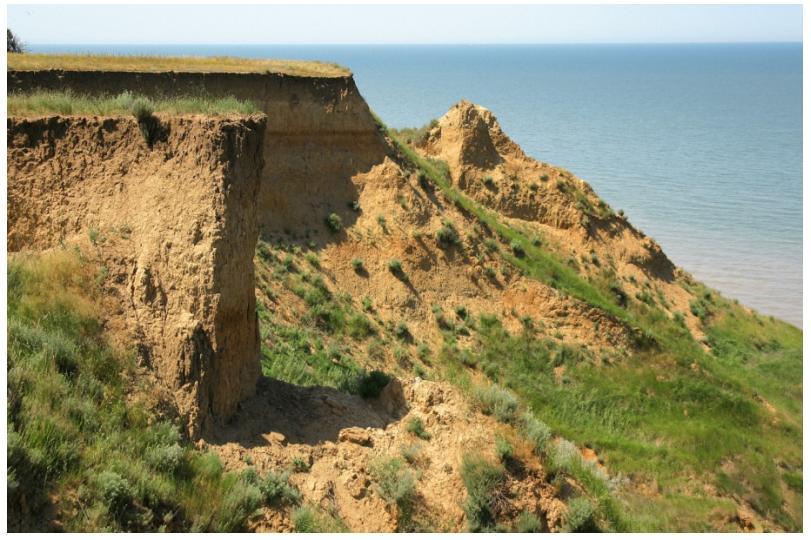
Fig. 3. Abrasion-falling coastal structure at the Azov seashore.

In Fig. 3 and Fig. 4 are shown abrasion-falling and abrasion-landslide coastal structures for mentioned above shores types of the Black and Azov seas.

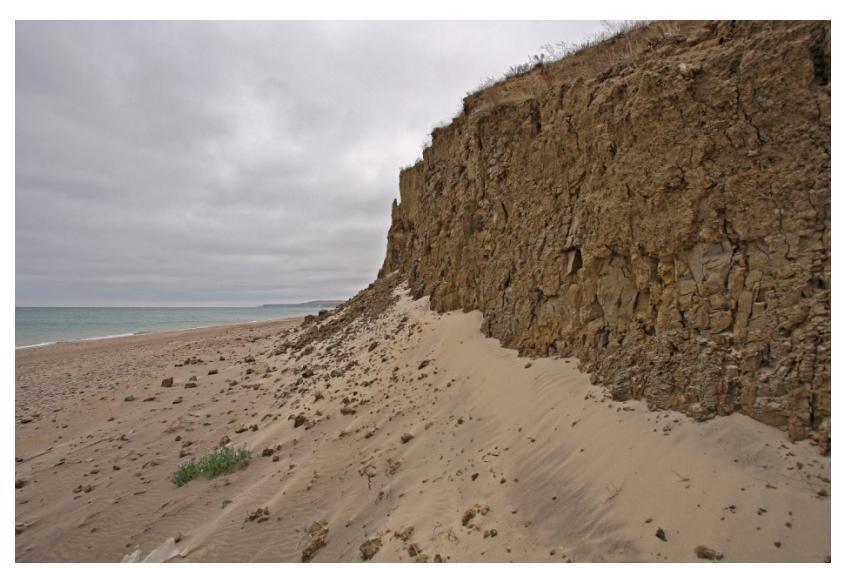
Fig. 4. Abrasion-landslide shore near the village of Veselovka.

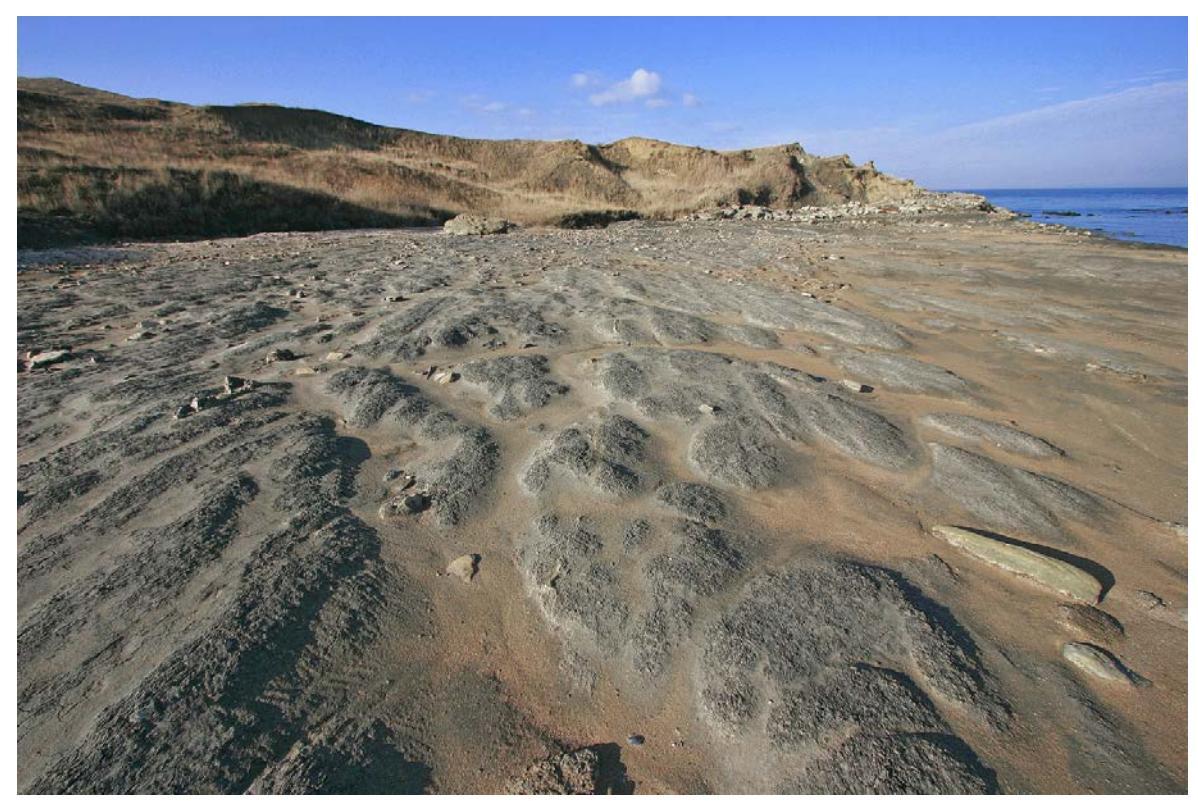
Fig. 5. Fields of breccias ejection in the places of naked seabed.

During the night of 29 to 30 April 2011, in the area of Kamennyi cape has happened neotectonic lifting of the bottom the Sea of Azov, with the capture of the shoreline. Surface area of the raising amounted to 10 ha, approximately. The amplitude of uplifting was more than 5 m in relation to sea level [4]. The observations showed, that the rise of the seabed caused by the deformation of anticlinal folds, so far as the elevation was formed from bedrock. The rocks have undergone significant deformation and outcropped on the surface of the elevation under the angle to 80° . Fields of breccias ejection been visualized in the places of naked seabed (Fig. 5).

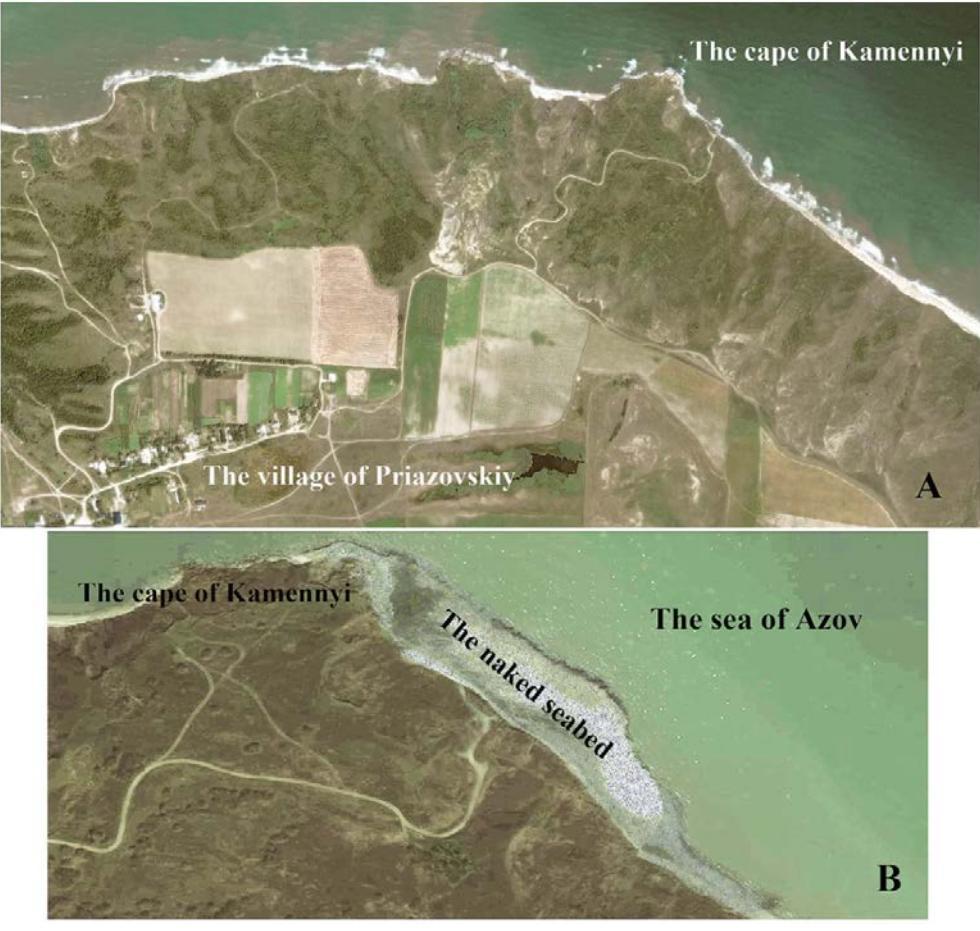
Fig. 6. The situation plan for neotectonic lifting: A - a satellite view before 29.04.2011; B - a satellite view after 29.04.2011.

In the immediate vicinity from the place of happened events situated the village. In Fig. 6 is shown situation plan for the moment of event.

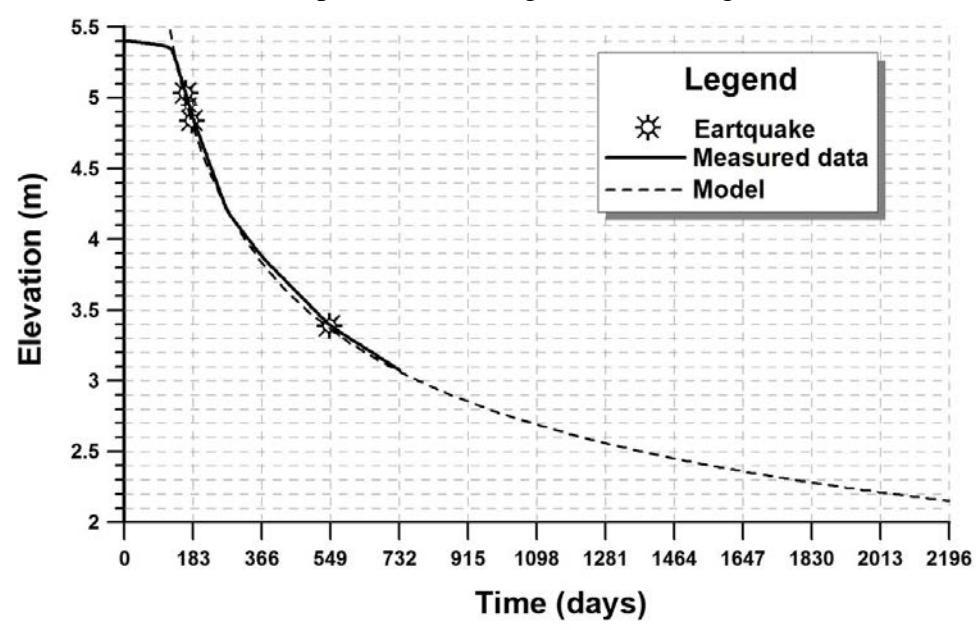
Fig. 7. Elevation changes of Kamennyi cape over a sea surface: data of monitoring and mathematical model.

In the process of field investigations was carried out the monitoring of the uplifted area. Changing of the cape elevations relative to sea level were recorded in during 3 years. Result of monitoring presents in Fig. 7. The figure shows, the North-Taman microplate a rate of subsidence varied from 3 to 25 cm per month during the monitoring.

Approximating of monitoring data has allowed mathematical derivation of changing the elevation over a sea surface. The equation looks like (1).

$$ln(Y) = -0.3228030356 \ln(61X/2) + 2.146247748$$
⁽¹⁾

The plate a rate of subsidence is easy to calculate. According to this model, the plate will return to its original level after 37 years.

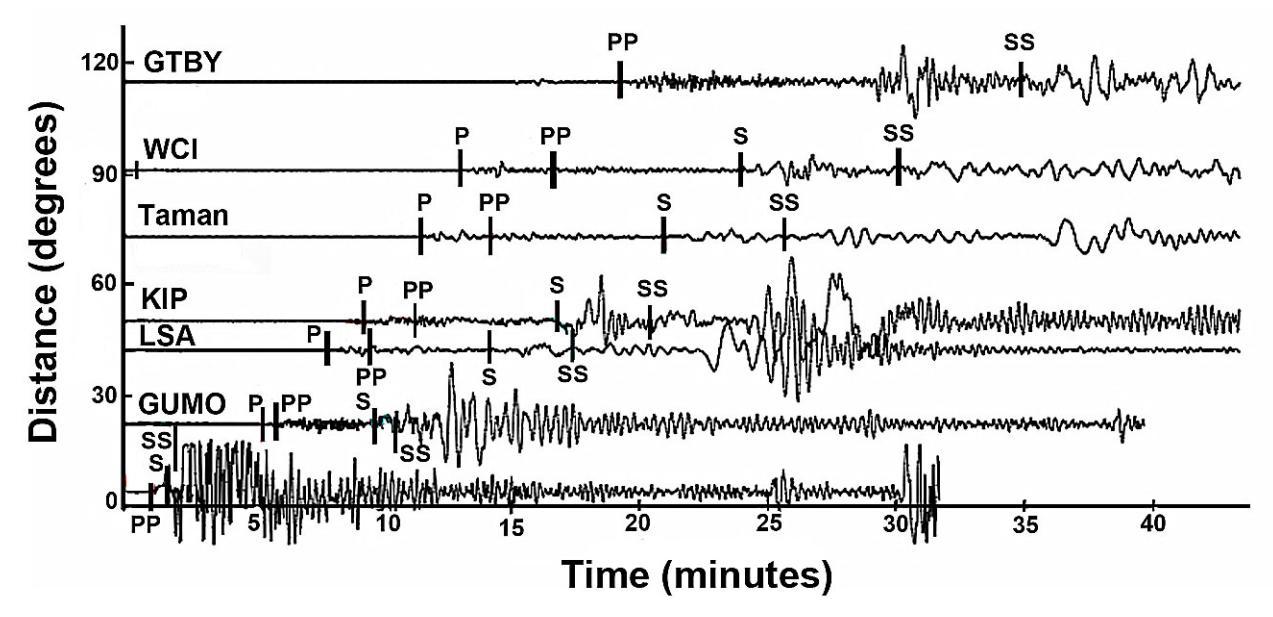
Fig. 8. The seismograms at different points of Earth and the types of seismic waves. P, S – waves inside of Earth's surface (the original, direct waves); PP, SS – added reflections at the underside of Earth's surface. Data from [5].

Types of seismic waves and the seismograms at different points presents in Fig. 8.

The seismograms show, waves which first of all came to the Taman region, were waves moving inside of Earth's surface. These waves have reached to Taman region in 12 minutes after the start of the earthquake. Surface waves have achieved the Taman region in 37 minutes after the start of the earthquake. The diagrams of seismic wave's propagation toward the Taman peninsulas after the earthquake start have shown in Fig. 9.

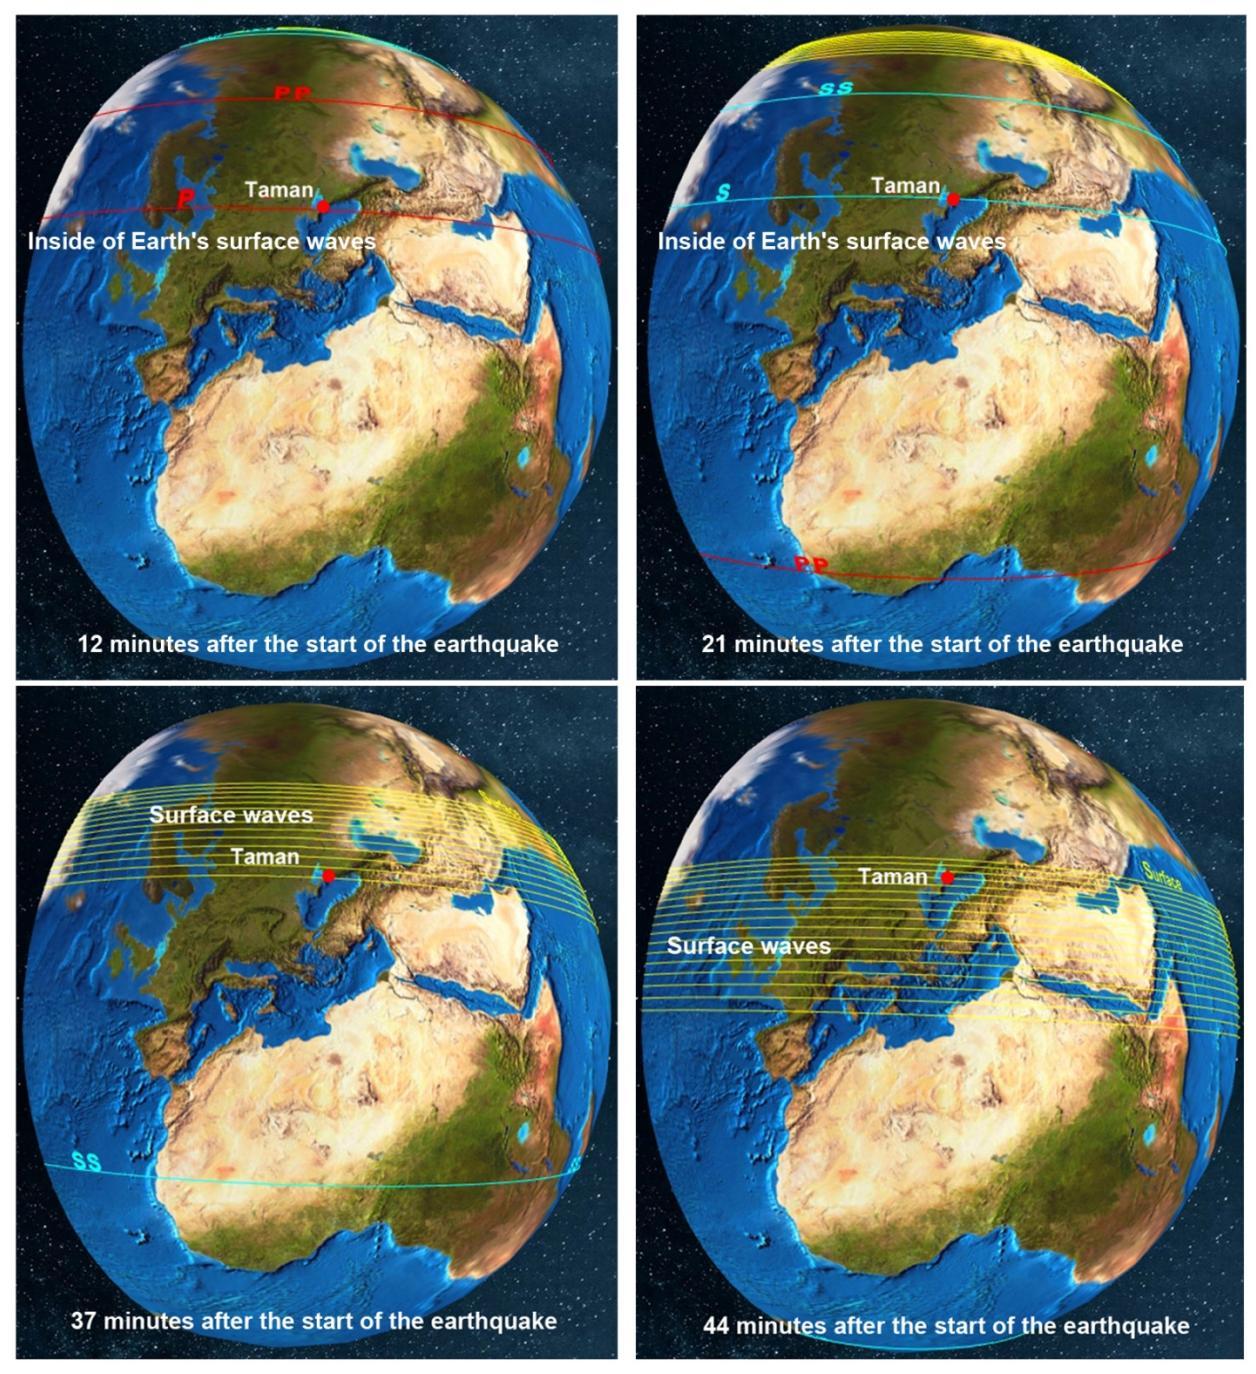
Fig. 9. The diagrams of seismic wave's propagation toward the Taman peninsulas after the earthquake start.

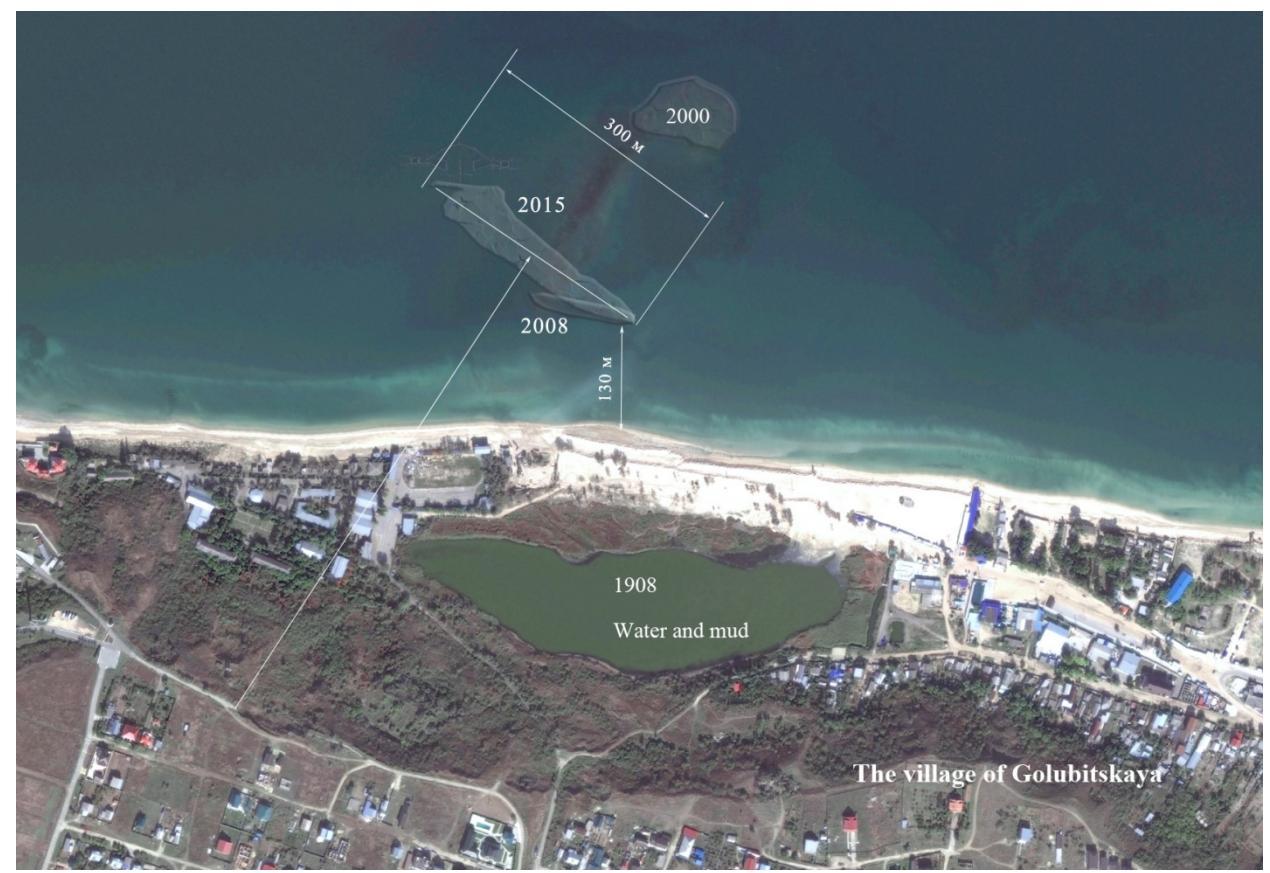
Fig. 10. The position of known mud volcano eruptions, from 1908 till 2015.

Another dramatic example of an event repeated with alarming frequency. Every 7-8 years within a village of Golubitskaya (in the sea) is happening eruption of a mud volcano. In 1908, the mud volcano eruption happened at the land. Now it is Caldera. It filled with water and mud. In 2000, the mud volcano eruption happened in the sea, about 300 m from the shore. An island formed in the process of volcano eruption. In June 2008, the mud volcano eruption happened about 100 m from the shore. An island has formed again. New the mud volcano eruption happened on October 25, 2015. A new formed island was much larger than island has formed after previous mud eruption. The places of named volcano eruptions have shown in Fig. 10.

What is possible to say about an anomaly No. 2? The tectonic stresses' discharge frequency for Golubitskaya region is 6-8 years. Next mud volcano eruption is possible to wait about year 2023. Fig. 10 shows, the place of volcano eruption is not stable. It migrates from one eruption to another. There is a possibility it can displaced to the direction of the village. Also important is the factor of intensive radon emission during the eruption. Measurements, made in year 2011 at the cape of Kamennyi, showed an excess of radon concentrations relative to the background in 800 times. 97% of the radon will decay only 20 days after eruption. All this time populations will be at increased radiation exposure.

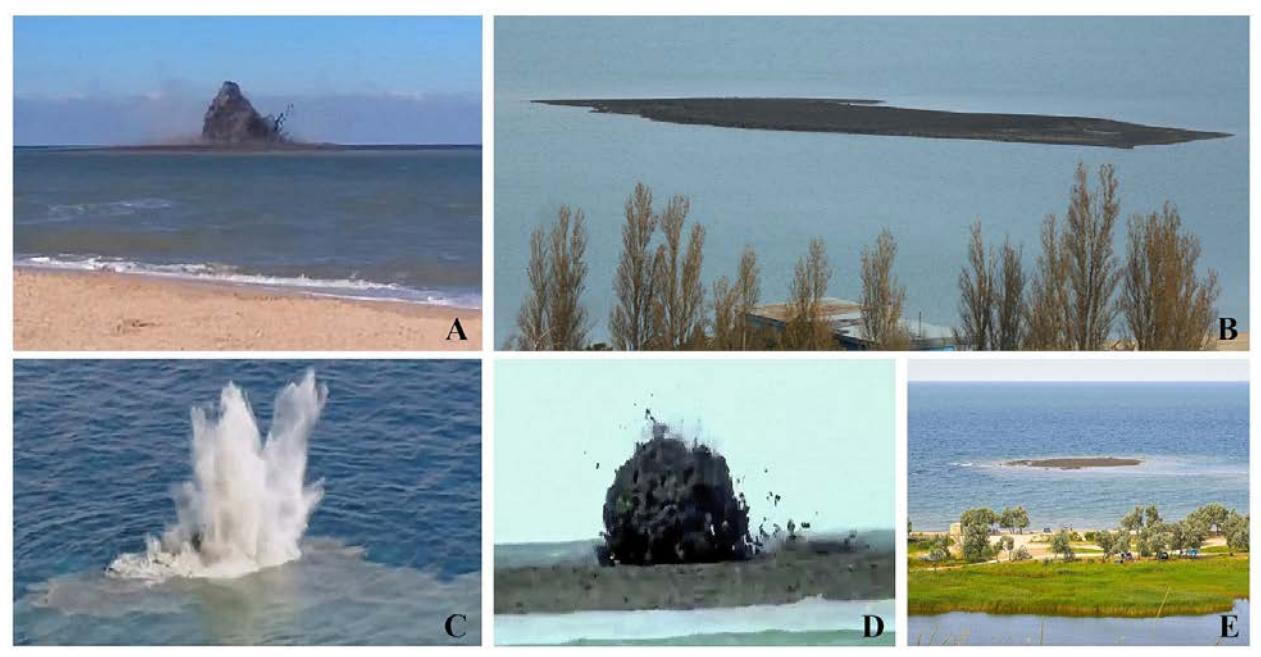
Fig. 11. Here are fragments of volcano eruption. In addition, islands, formed after each eruption. A – October 25, 2015; B – December 05, 2015; C, D – June 2008; E – July 01, 2008.

Fragments of volcano eruptions have shown in Fig. 11A, Fig. 11C and Fig. 11D. Also in Fig. 11B and Fig. 11E are displayed islands, have been formed after each volcanic eruption.

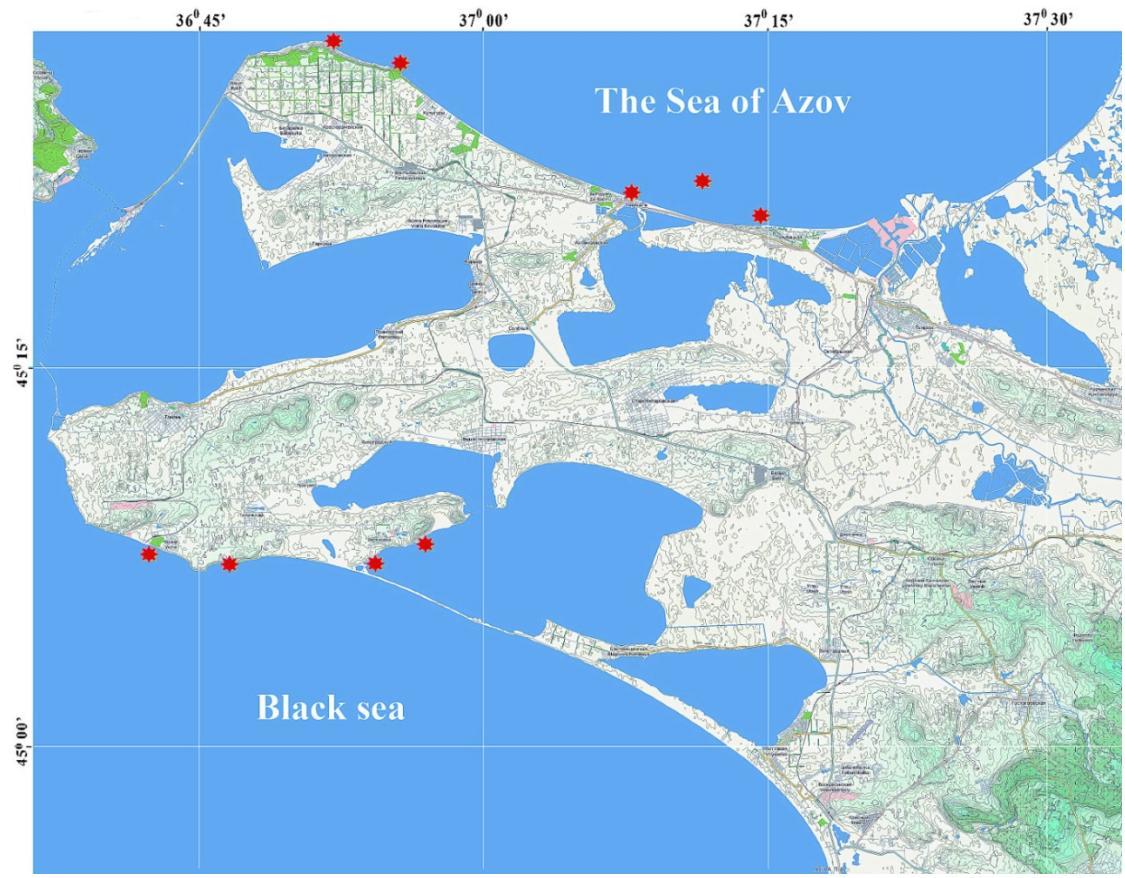
Fig. 12. Potentially dangerous places at the region of Taman peninsula.

As has been said, the state of geological structures of Taman region has characterized as "stress-strain". The article gives only the most vivid events of recent years. To consider in detail all potentially dangerous situations for the peninsula is quite difficult. In Fig. 12 shows the locations of the possible expressions of dangerous natural events related to tectonic processes. The catastrophic events, occurring in any place of the globe, may to disrupt the "fragile stability".
